UK MKIII Supra Owners Group

Changing the Spark Plug Valley Cover

Author	J Seaman
Date	29/08/07
Version	1.00
Edited by	NA

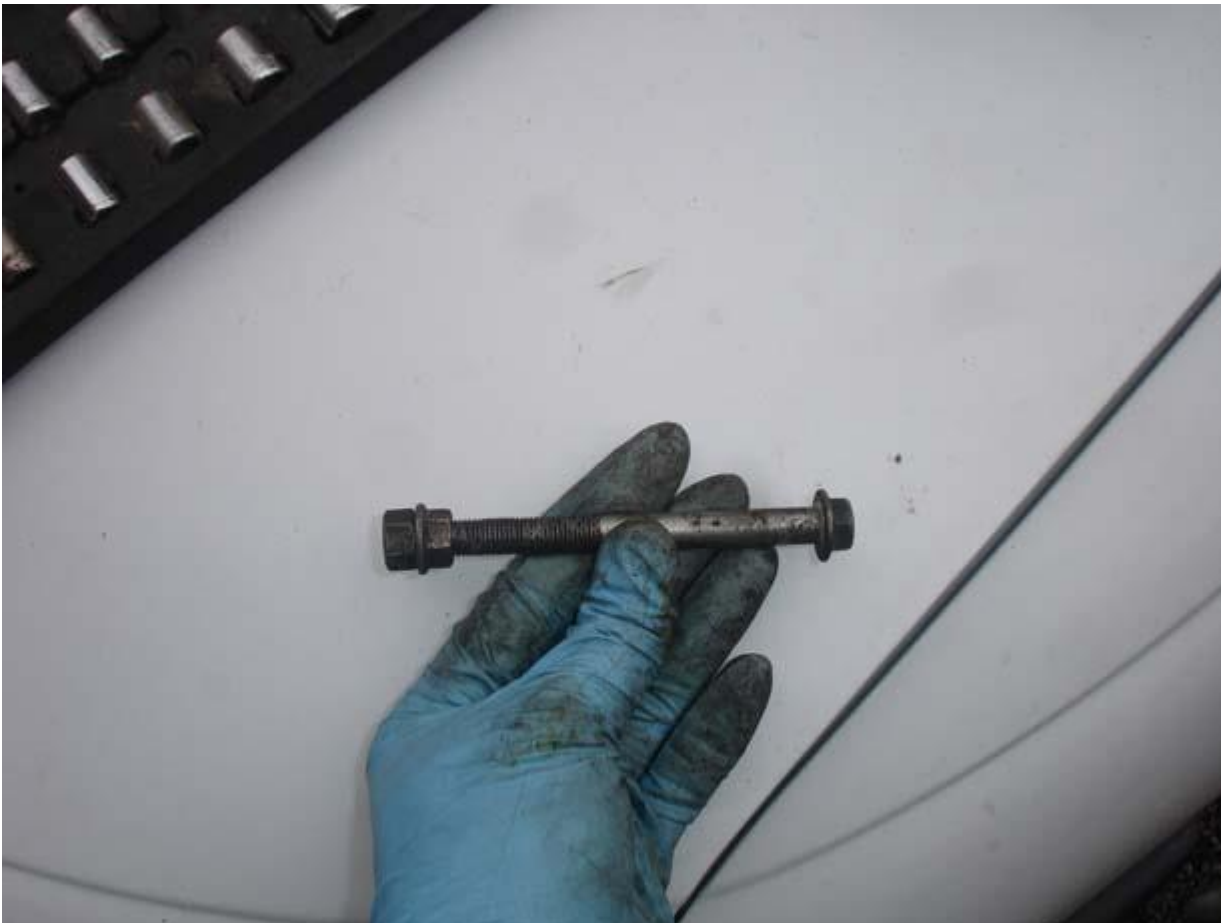
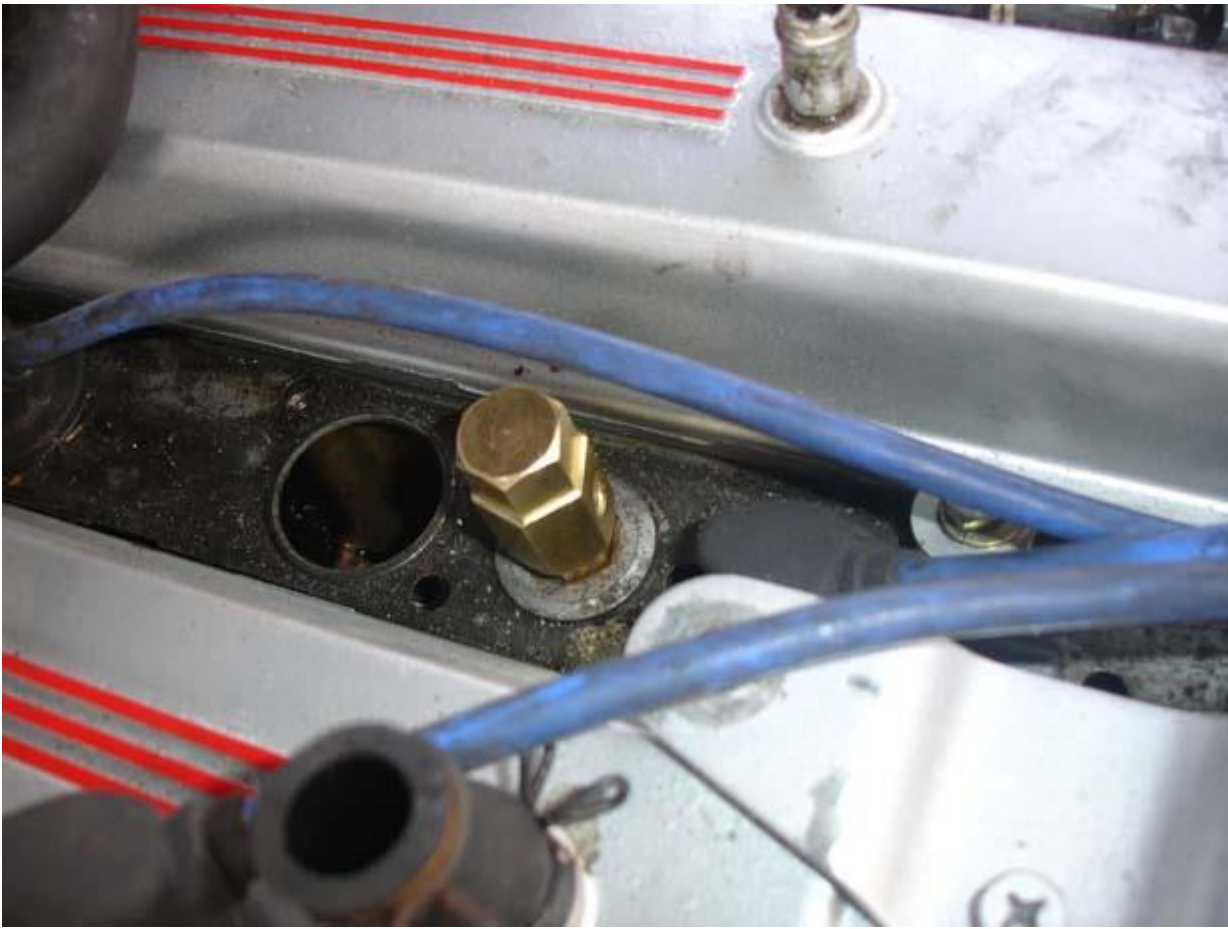
Step 2 - To remove the old cover (Number 3 cylinder head cover to Toyota) you will need a 14mm hex tool. One method is to get an old 14mm bolt and then stick a couple of nuts back to back as shown in the first picture. I had very little success with this, I just kept threading bolts.

My recommendation is to buy a 14mm hex key or a cheaper alternative is a 14mm sump nut remover. This gives you a 17mm socket connection on the other end which is handy too

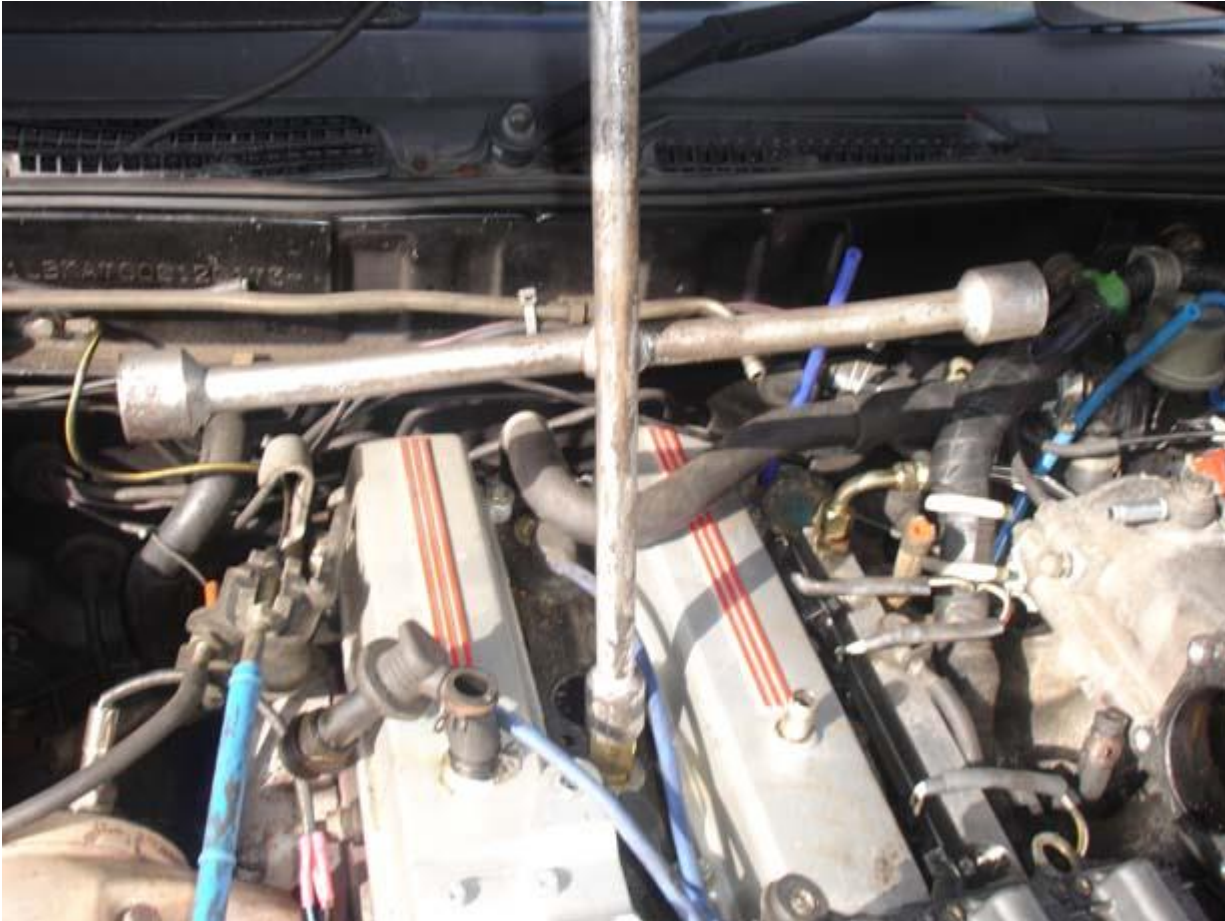
Step 3 - Your cover will probably not have been replaced for a very long time so expect a lot of resistance. I use a wheel brace on my sump nut remover to crack the 4 nuts off

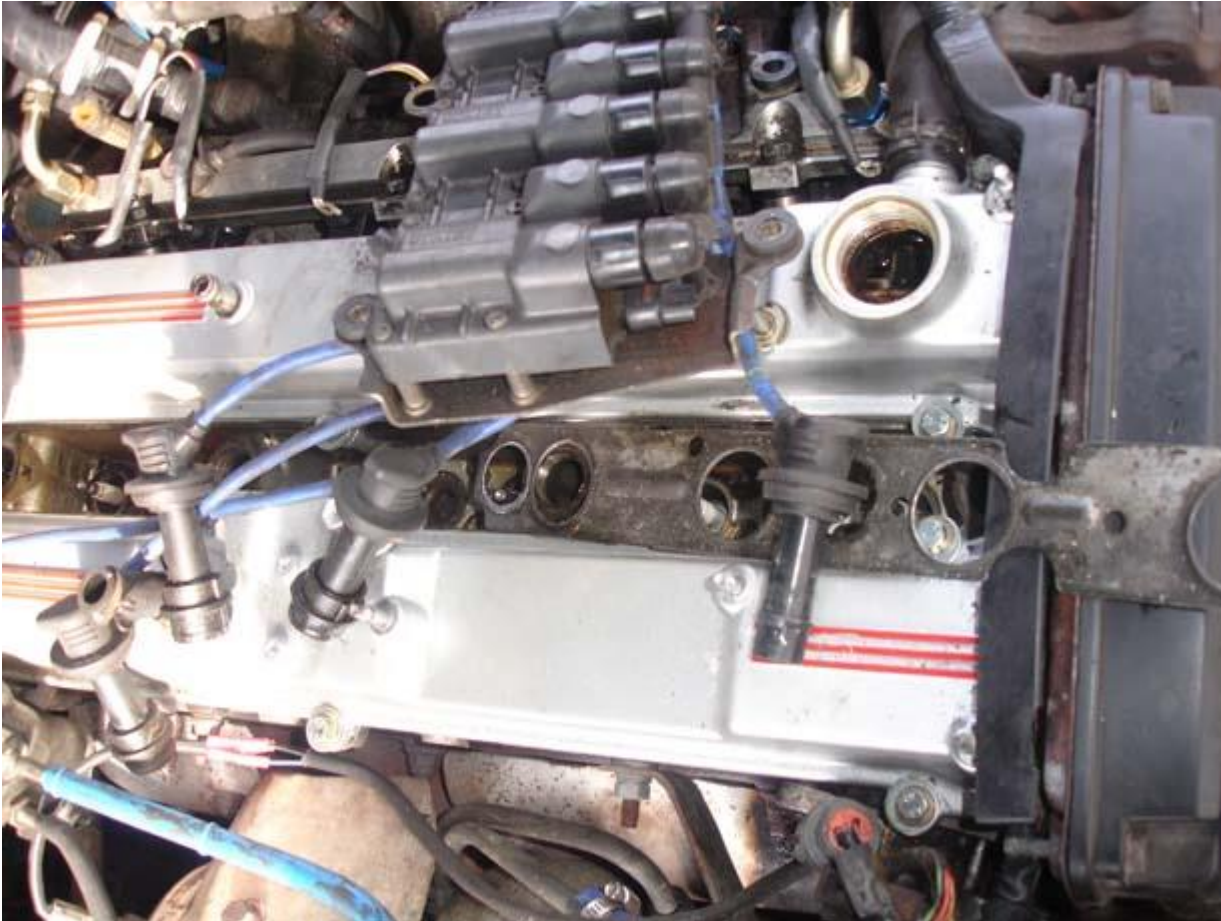
Step 4 - Once you've undone all 4 nuts, remove the HT leads from the plugs (you can just shift the coil pack to one side, no need to undo all the leads) and slide the gasket out forwards

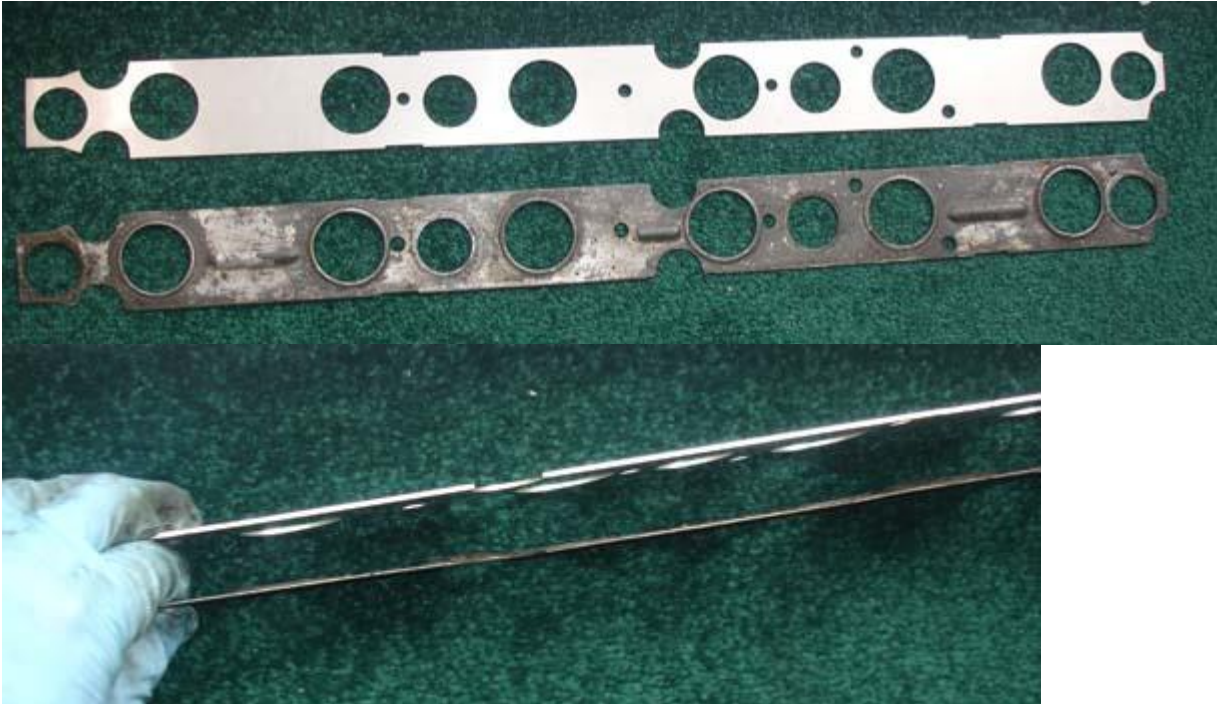
Step 5 - Get one nice shiny new cover, preferably a stainless one from Steve (Group A Supra) because they rock. Second pic shows the thickness difference, stock one looks very cheap and nasty in comparison

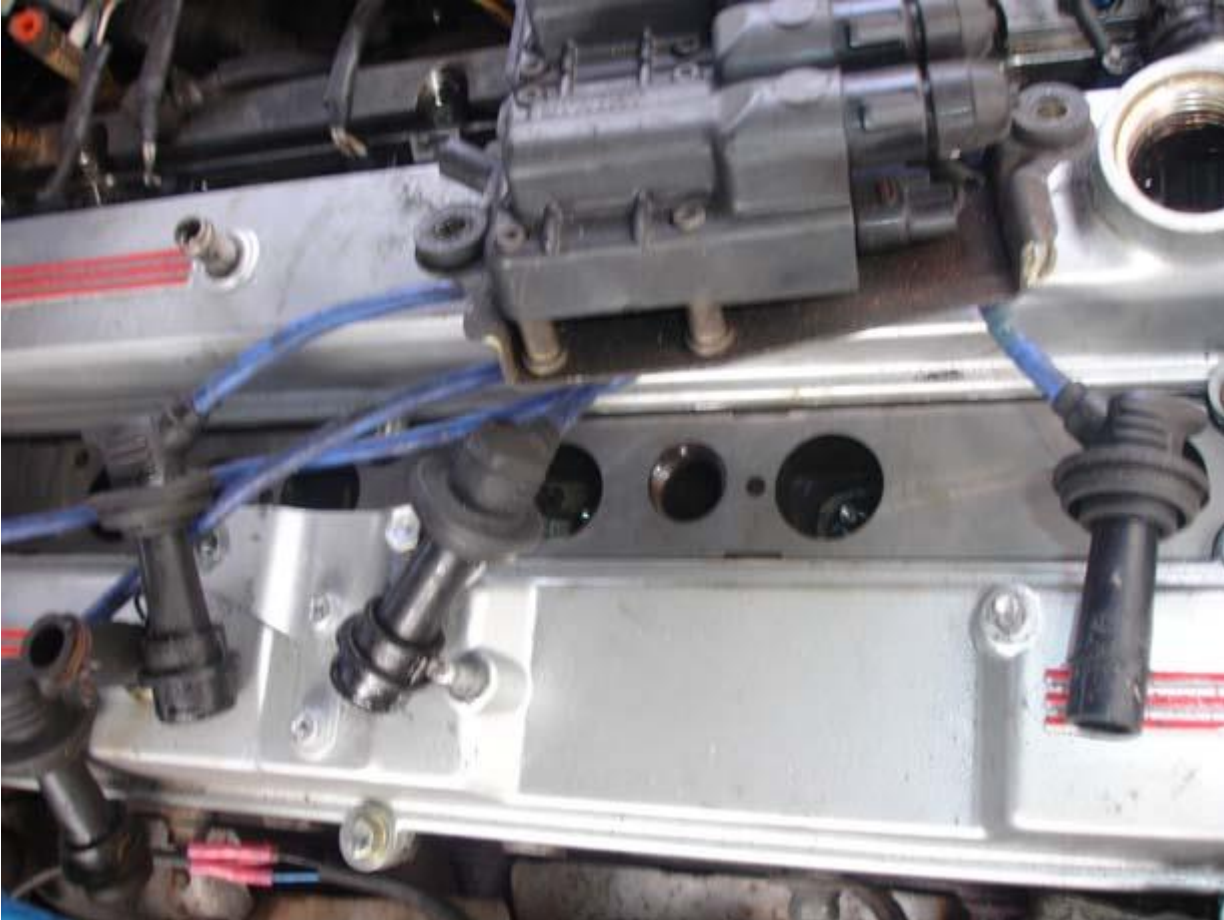
Step 6 - Slide the new gasket in

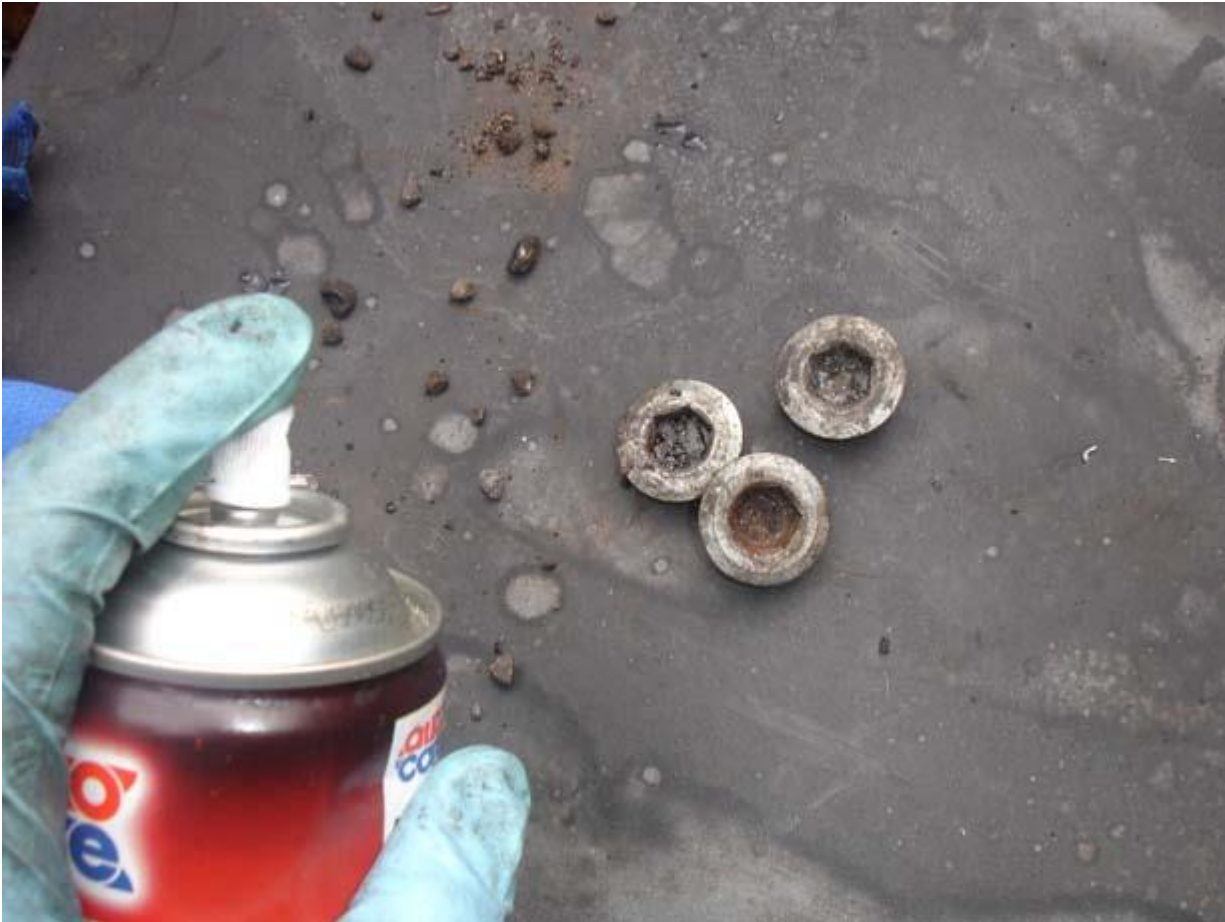
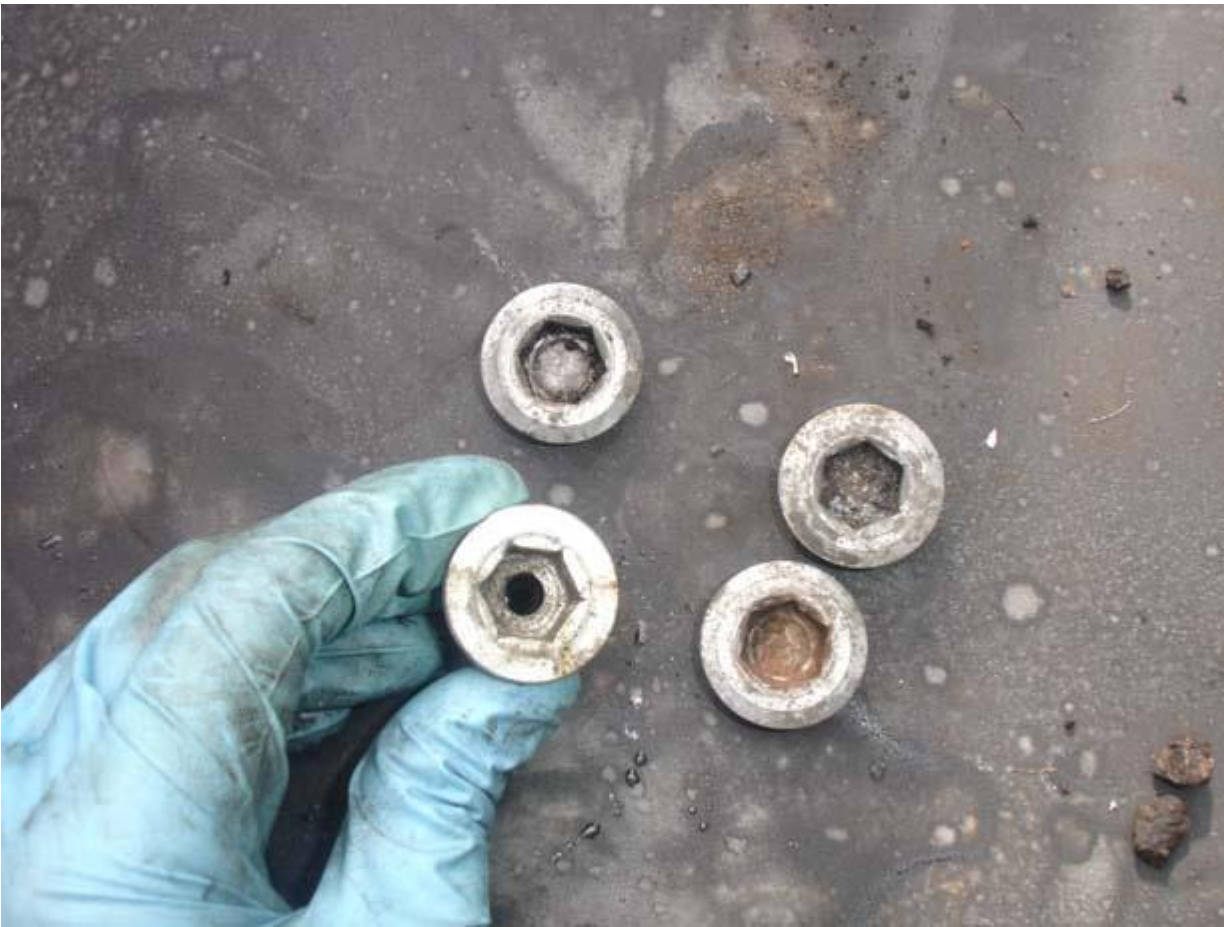
Step 7 - Spray some carb cleaner on the rusty nuts (picture 1) and they should clean up a little (picture 2)

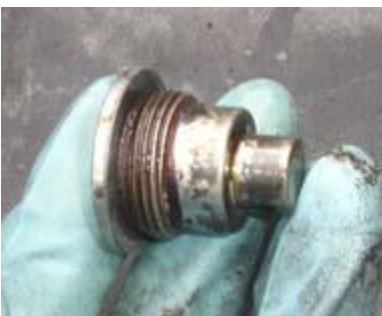
Step 8 - Note that all nuts are the same except for the rear one that looks like this

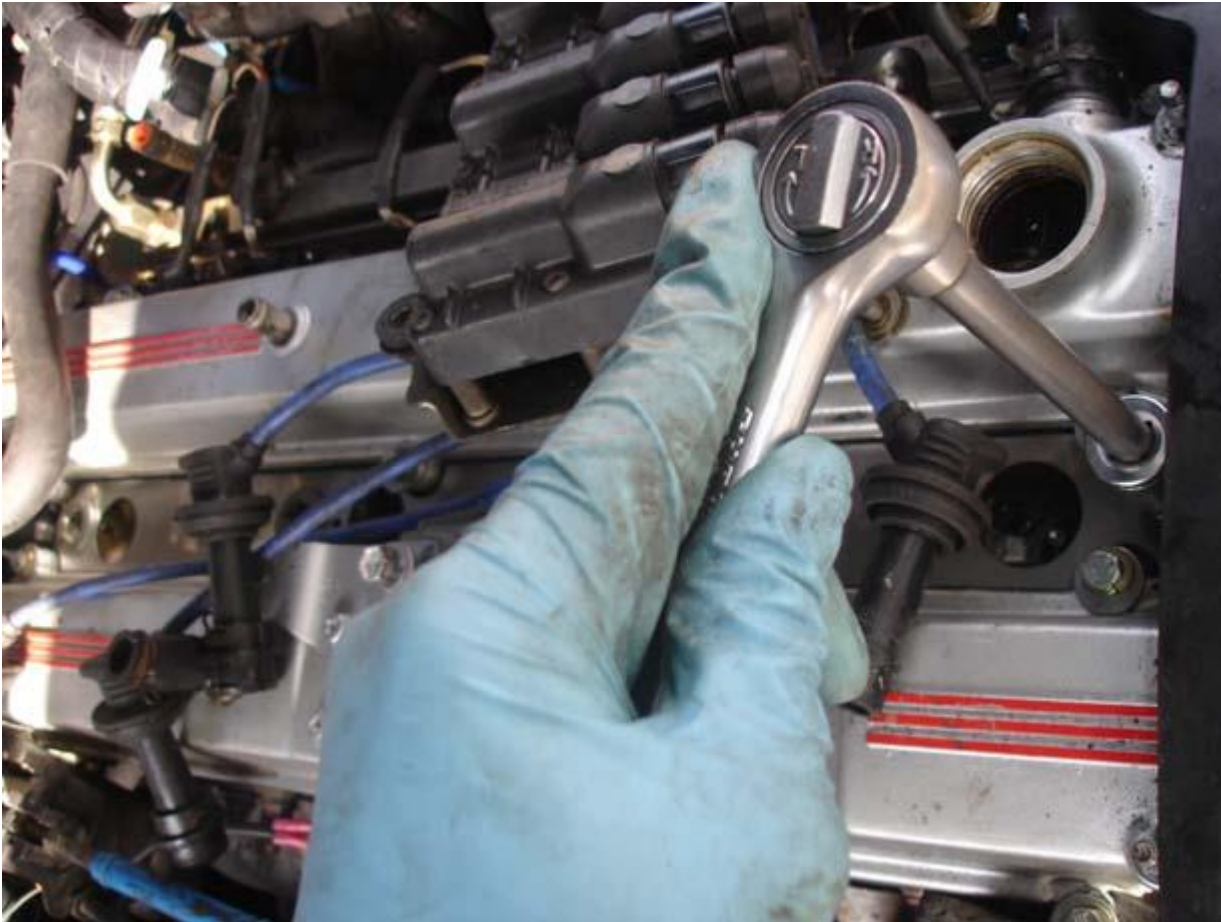
Step 9 - Fit your cleaned up nuts back in place and tighten them down

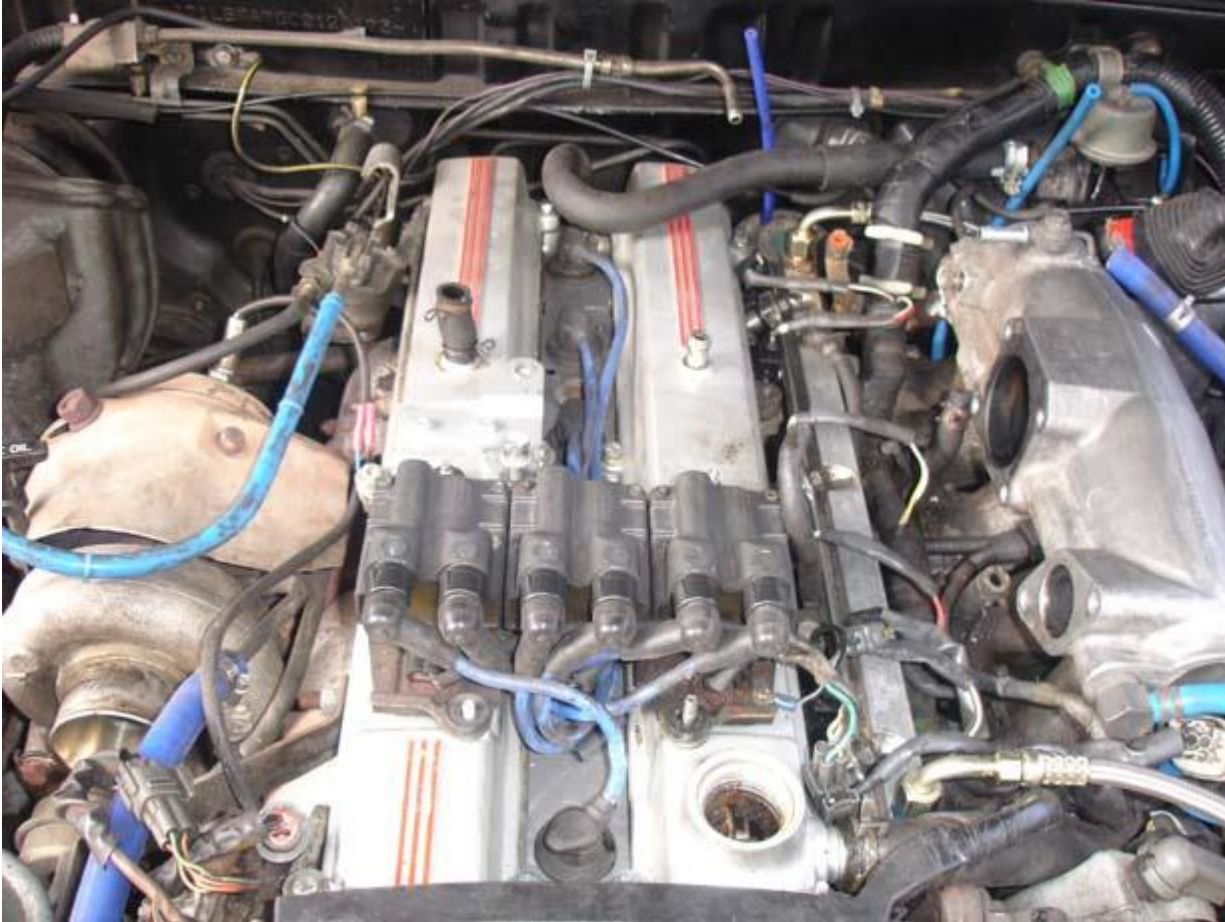
Step 10 - Refit the leads and coil pack then admire your new cover
