UK MKIII Supra Owners Group

Removing the PCV System

Author	J Seaman
Date	29/08/07
Version	1.00
Edited by	NA

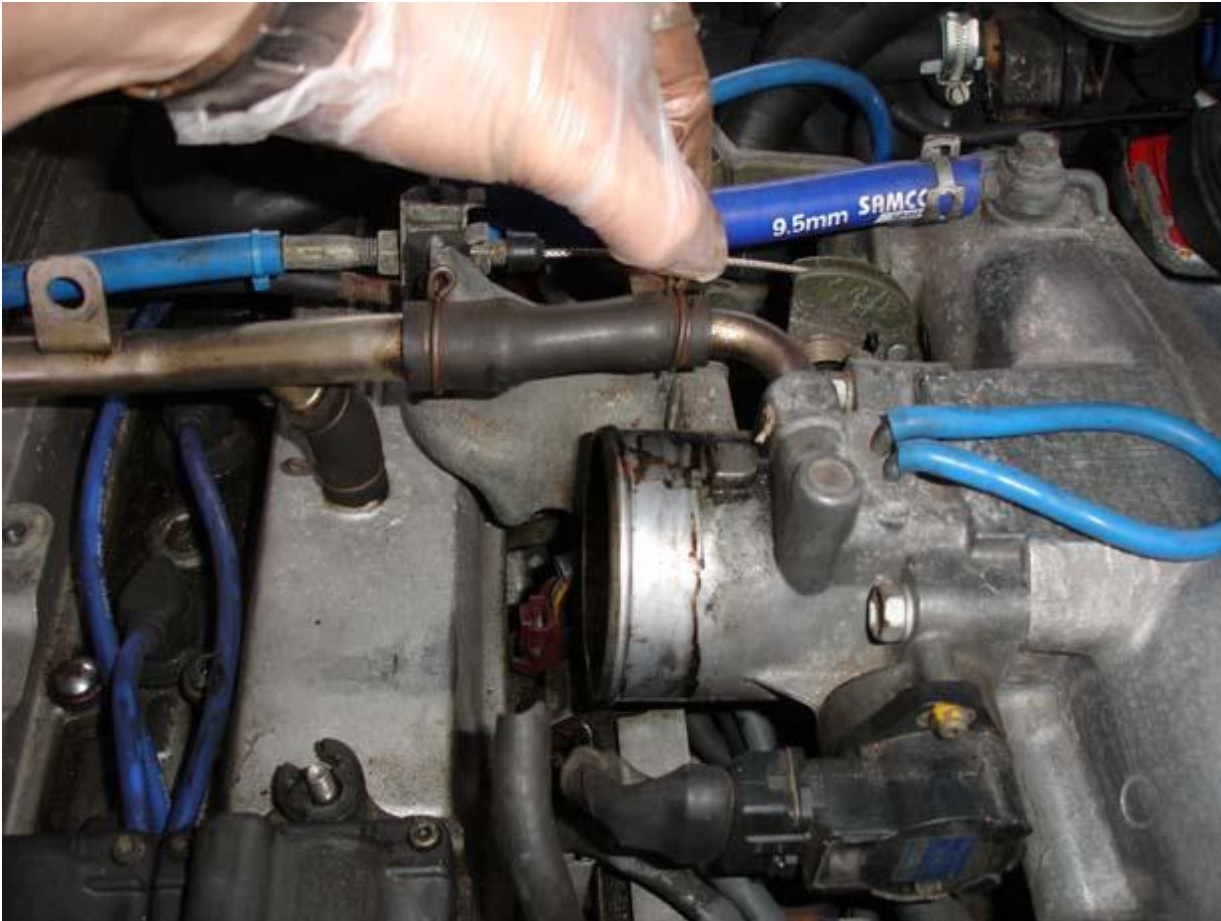
Step 2 - Squeeze the metal clip connecting the PCV system to the throttle body and work it back down the pipe so it doesn't hold the rubber hose on to the metal tube

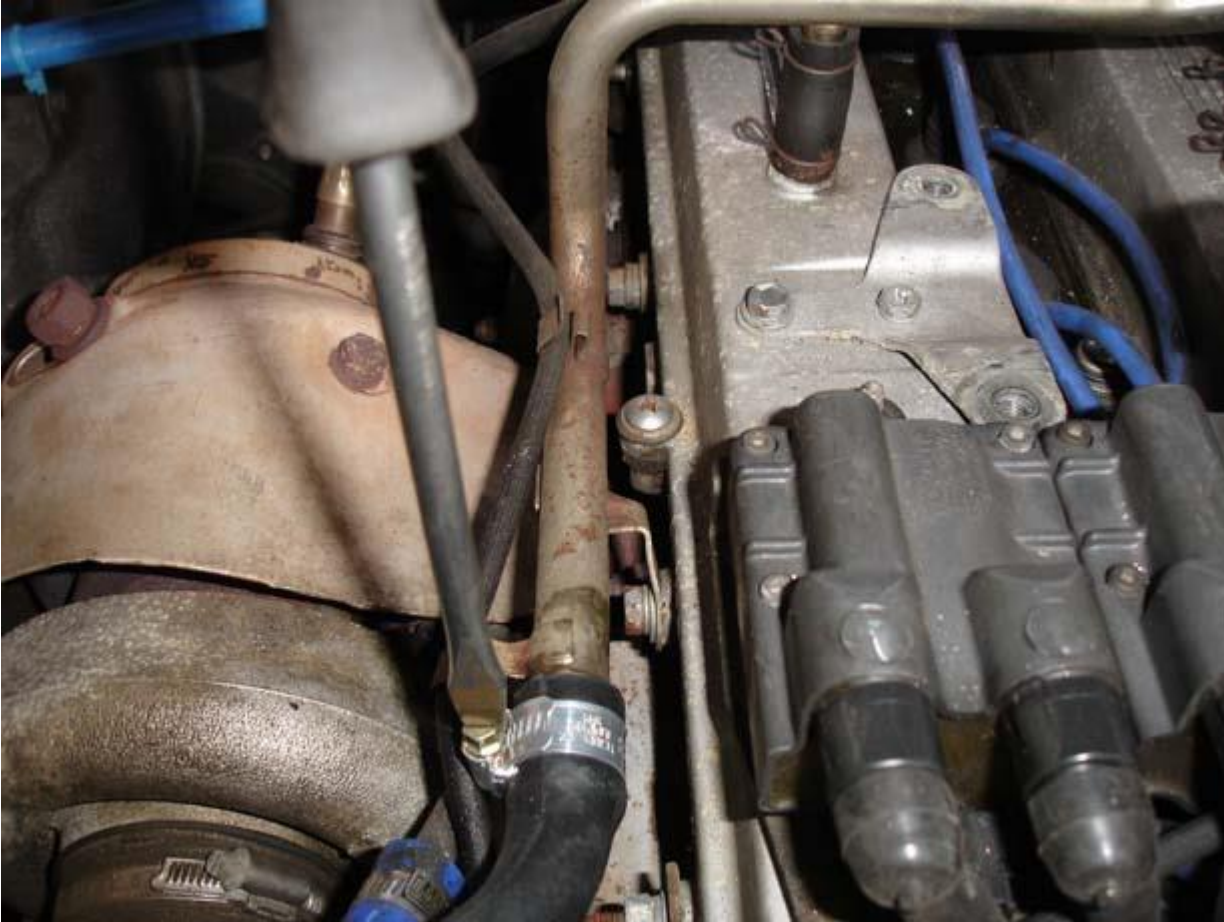
Step 3 - Undo the jubilee clip at the other end of this pipe that connects to the accordion hose

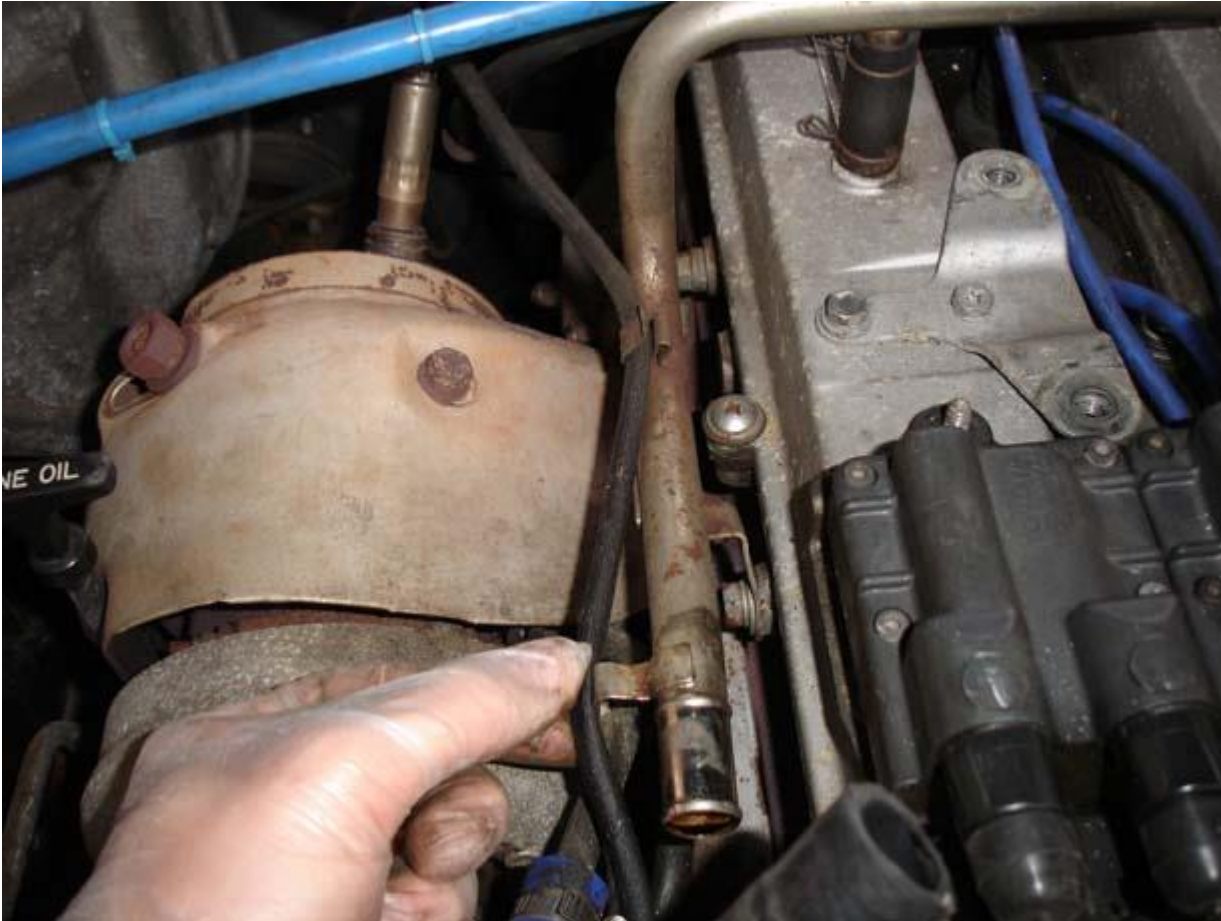
Step 4 - Pull back the metal clips that hold the wiring for the lambda sensor in place and move the wire clear of the pipework

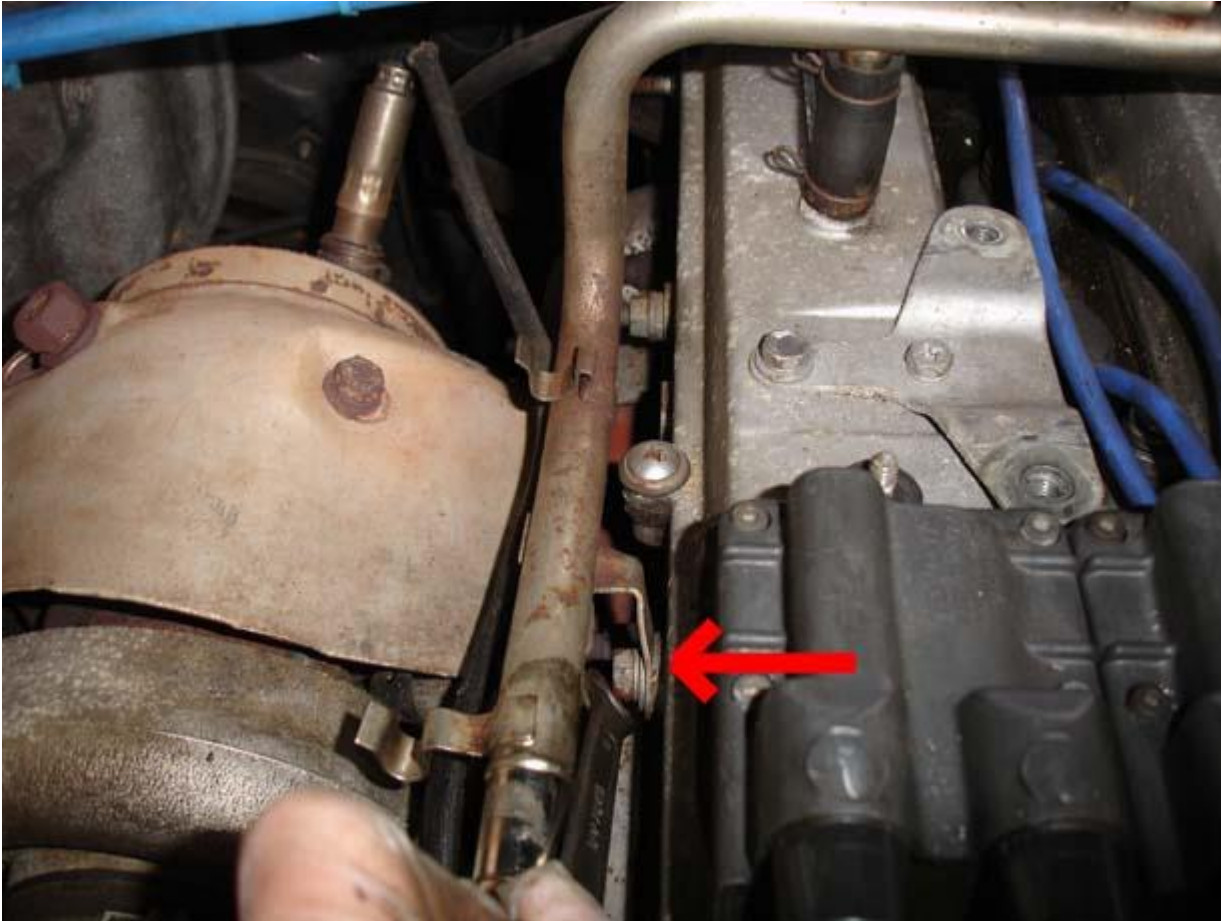
Step 5 - Use a spanner to undo the 12mm bolt holding the bracket for the PCV pipe in place. Be careful not to drop the bolt, undo the last bit with your fingers

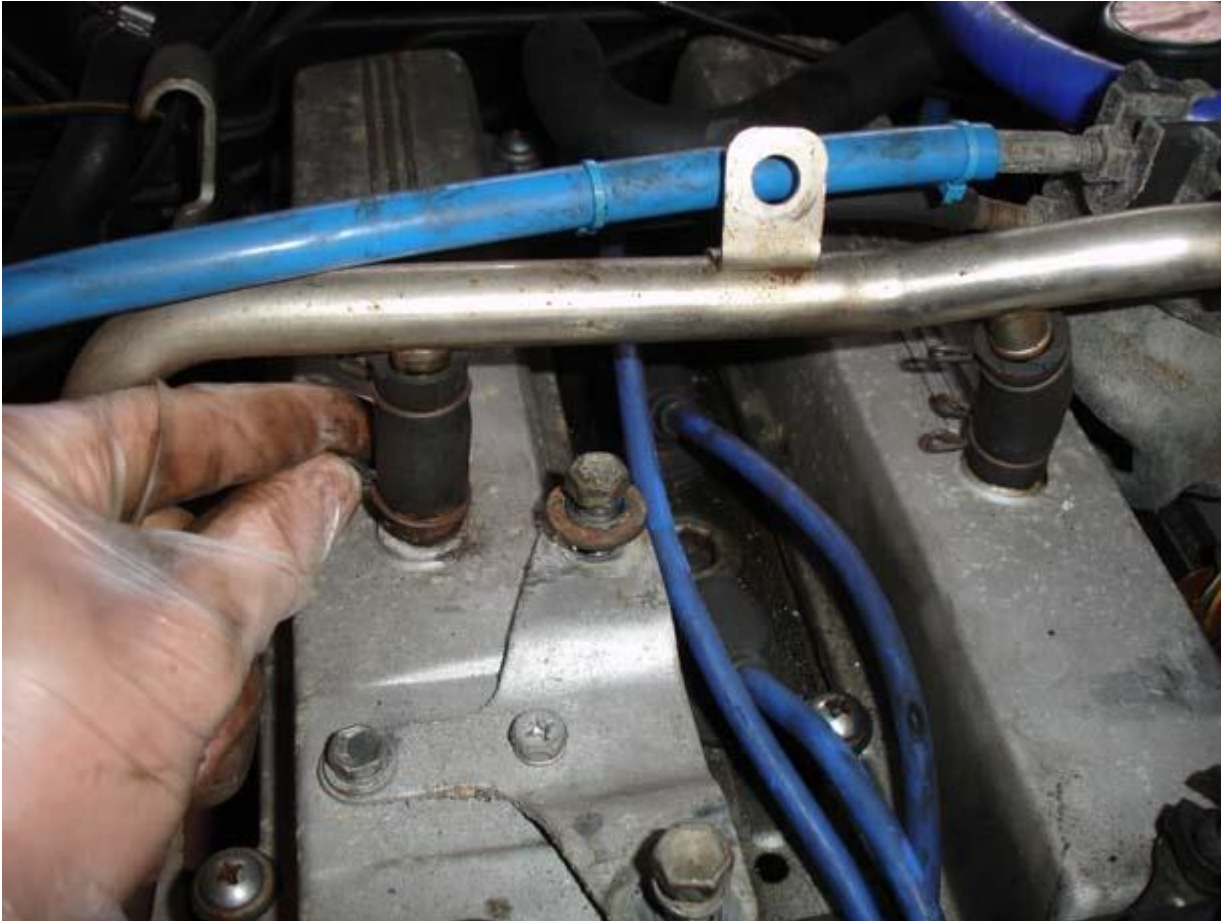
Step 6 - Retract the metal spring clips up the rubber hose for both the cam cover breathers. You want to pull the rubber hose away with the pipework rather than leaving them connected to the cam covers

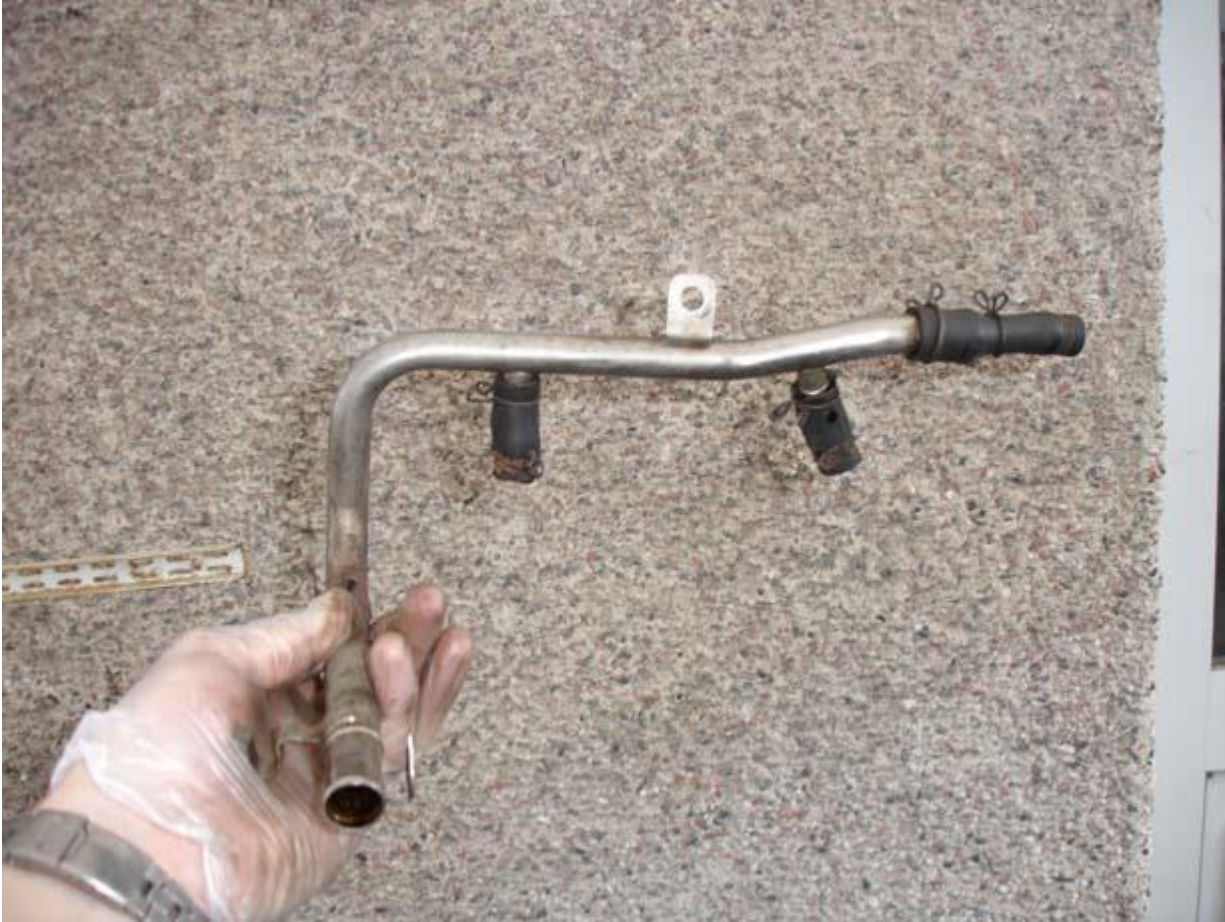
Step 7 - Pull the pipework free from the vehicle
